## Testing the wear of wheelsets of EN97 series vehicles in terms of geometrical parameters of the wheel profile in two-year operation

*The article presents the results of wheel wear tests of selected EN97 series electric multiple units. In the tests carried out on the 14 vehicles mentioned above, which were driven on the same route, geometrical parameters of the profile of all wheels were recorded during periodic inspections. The analyzed data concerned the period of over two years of use, when the vehicles were delivered from the manufacturer to the carrier as new. In the form of graphs, cases of exceeding a given parameter in relation to the requirements set in the Maintenance System Documentation are presented, broken down into individual wheelsets. The article presents the results of operational tests, which show which wheel set parameters (wheel diameter, rim steepness, rim thickness, rim height, etc.) are most often exceeded and which are least. The analyzes of the geometric parameters of the wheel profile on the tested group of vehicles, which were used on the same route in the same period, clearly prove that the parameters most often exceeded are wheel diameter and rim st

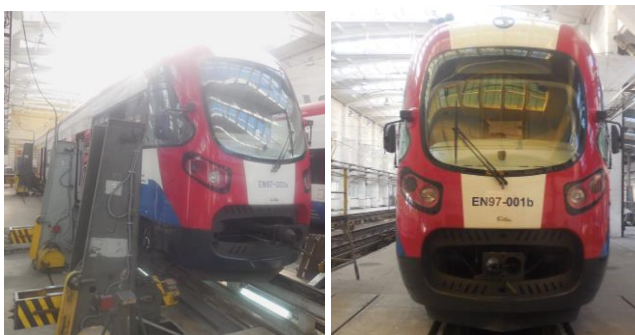
Fig. 2. View of the EN97 vehicle number 001 during service in the inspection and repair hall

Three-unit type n+t+n (driving unit + rolling unit + driving unit) of the EN97 vehicle are based on three bogies, one person for each unit, the driving extremes and the middle rolling bogie, as shown in Fig. 1. A general view of the electric multiple unit is shown in Fig. 2. Figure 3 shows the view of the vehicle's bogies.

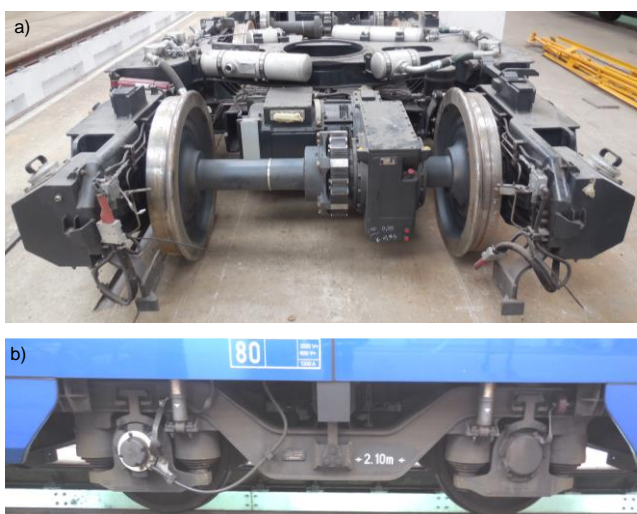
Fig. 3. View of the bogies of the EN97 vehicle: a) the 34MN driving bogie disassembled with the transmission and traction motor visible, b) the view of the 4AN rolling bogie under the middle section

An important feature that distinguishes both bogies, apart from their purpose, is the wheelbase of the wheelsets (bogie base). In the case of 34 MN drive bogies, the wheelbase is 2300 mm, while in the 43AN bogies – 2100 mm. Two traction motors with a power of 180 kW each are mounted on each driving trolley [3, 4].

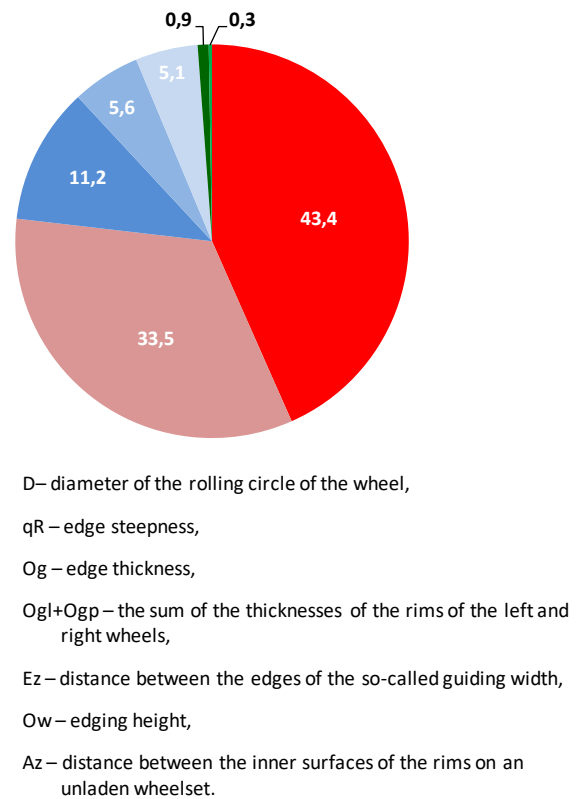
Fig. 6. Percentage of exceeding a given ZK parameter to all exceedances of geometric parameters found in time P2
