Testing the wear of wheelsets of EN97 series vehicles in terms of geometrical parameters of the wheel profile in two-year operation

The article presents the results of wheel wear tests of selected EN97 series electric multiple units. In the tests carried out on the 14 vehicles mentioned above, which were driven on the same route, geometrical parameters of the profile of all wheels were recorded during periodic inspections. The analyzed data concerned the period of over two years of use, when the vehicles were delivered from the manufacturer to the carrier as new. In the form of graphs, cases of exceeding a given parameter in relation to the requirements set in the Maintenance System Documentation are presented, broken down into individual wheelsets. The article presents the results of operational tests, which show which wheel set parameters (wheel diameter, rim steepness, rim thickness, rim height, etc.) are most often exceeded and which are least. The analyzes of the geometric parameters of the wheel profile on the tested group of vehicles, which were used on the same route in the same period, clearly prove that the parameters most often exceeded are wheel diameter and rim steepn

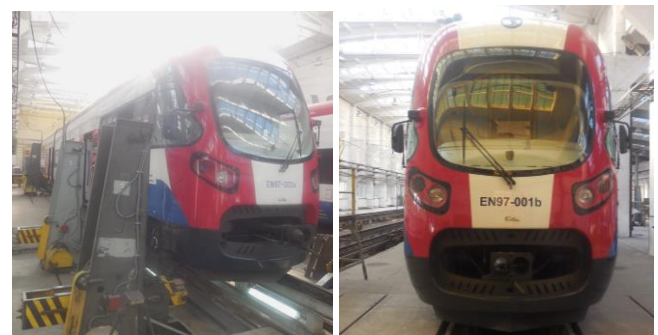
Fig. 2. View of the EN97 vehicle number 001 during service in the inspection and repair hall

Three-unit type n+t+n (driving unit + rolling unit + driving unit) of the EN97 vehicle are based on three bogies, one person for each unit, the driving extremes and the middle rolling bogie, as shown in Fig. 1. A general view of the electric multiple unit is shown in Fig. 2. Figure 3 shows the view of the vehicle's bogies.

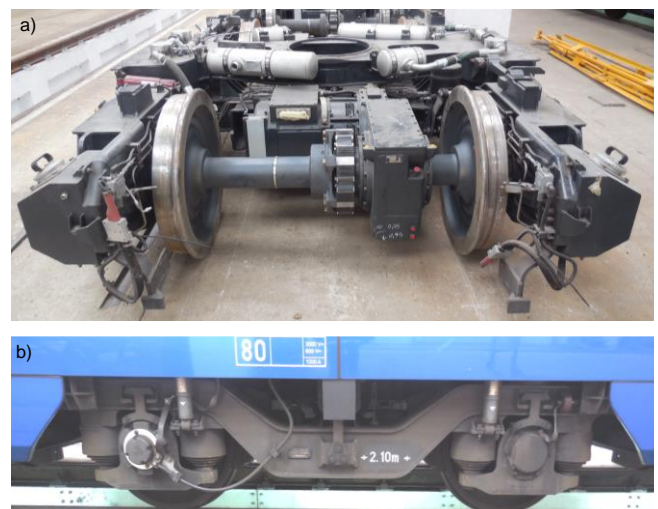
Fig. 3. View of the bogies of the EN97 vehicle: a) the 34MN driving bogie disassembled with the transmission and traction motor visible, b) the view of the 4AN rolling bogie under the middle section

An important feature that distinguishes both bogies, apart from their purpose, is the wheelbase of the wheelsets (bogie base). In the case of 34 MN drive bogies, the wheelbase is 2300 mm, while in the 43AN bogies – 2100 mm. Two traction motors with a power of 180 kW each are mounted on each driving trolley [3, 4].

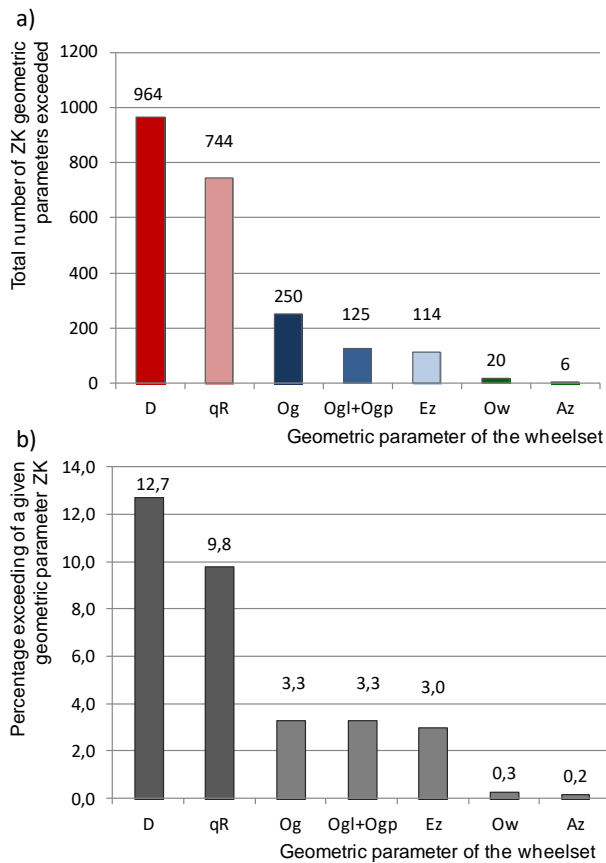
Fig. 5. Summary a) quantitative, b) percentage exceedances of a given wheel set parameter during the P2 inspection for the 14 vehicles tested over a period of 2 years

Figure 5a presents a quantitative summary of cases of exceeding a given wheel set parameter with the requirements contained in the Maintenance System Documentation, found during the P2 inspection. The results in Fig. 5a were recorded after a total of 41,712 measurements of wheelsets on 14 vehicles over a period of more than two years. On the other hand, Fig. 5b shows the percentage of exceeding a given parameter of the wheelset related not to all ZK measurements, but only to the measurements of a given parameter. For example, the exceeded wheel diameter in the rolling circle accounts for 12.7% of all wheel diameter measurements, i.e. 7,584, made on 14 vehicles in the same period (over 2 years) during the P2 level review. Figure 6 is a cumulative percentage list of cases of exceeding a given wheel set parameter related to the sum of all exceeding the parameters (D, qR, Og, Ogl+Ogp, Ez, Ow and Az), i.e. 2223 cases characterizing the wheel profile of the tested wheelsets.

Both the analysis of the results in terms of quantity and percentage of exceeding the geometrical parameters describing the wheelset proves that, first of all, the wheel diameter in the rolling circle was found most often during the measurements of the wheelset during P2 inspections. According to Fig. 5a, there were almost 1000 cases out of 7584 measurements of wheel diameters over the period of over 2 years of use of electric multiple units. The second place in terms of exceeded parameters to the DSU requirements was the edge steepness qR with the result of almost 750 cases out of 7584 measurements.

The next parameters, the number of exceedances of which were the same or similar, are the thickness of the rim Og, the sum of the thicknesses of the left and right rims Ogl+Ogp and the distance between the outlines of the rims Ez. Although Fig. 5a shows other exceedance values, comparing these results to the number of measurements of a given parameter, which in percentage terms is shown in Fig. 3b), very similar results were obtained. For example, the thickness of the rim with 250 exceedances was found during twice as many measurements, because both the right and left thickness of the rim had to be measured (7584 measurements), in the case of the sum of the thickness of the rims, 125 exceedances were found, and for param-

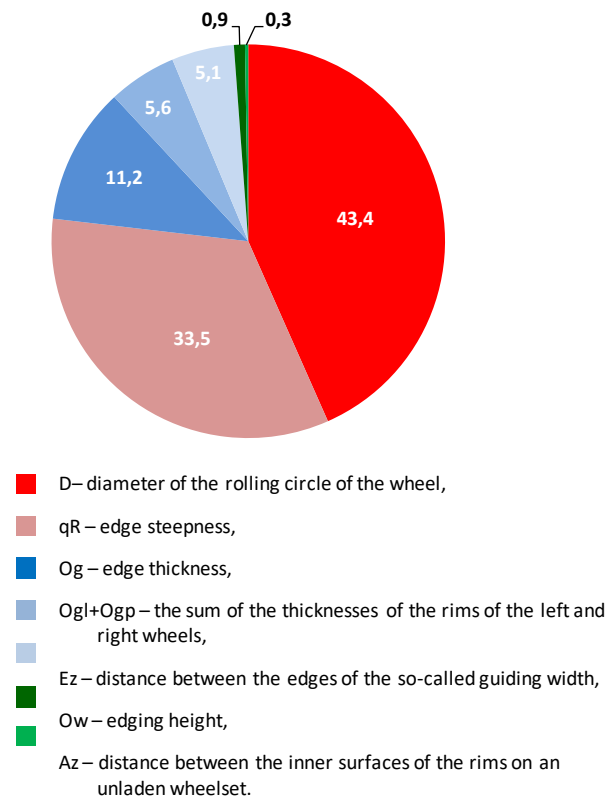
Fig. 6. Percentage of exceeding a given ZK parameter to all exceedances of geometrical parameters found in time P2

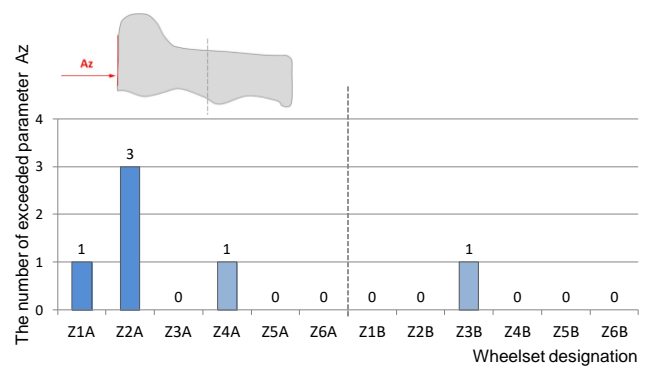
Fig. 13. The number of violations of the parameter of the distance between the inner surfaces of the rims in the unloaded wheelset Az during inspections P2

Analyzing the graphs presented in Fig. 7–13 of the number of exceedances of the geometric parameters of the tested wheelsets, it is found that the vast majority of the above-mentioned exceedances of parameters took place on the second wheelset of the first section (wheelset Z2A), which was found for 6 out of 7 parameters describing the geometry of the railway wheel. The second place in terms of exceeded geometric parameters was found on the first set of the first (A) and second tripartite of the EN97 Vehicle (wheelsets 1A and 1B), which was observed on 4 out
