## Maintenance of disc-brake wheelsets

wear  
wheelset  
brake disc  
railway wheel  
electric traction unit

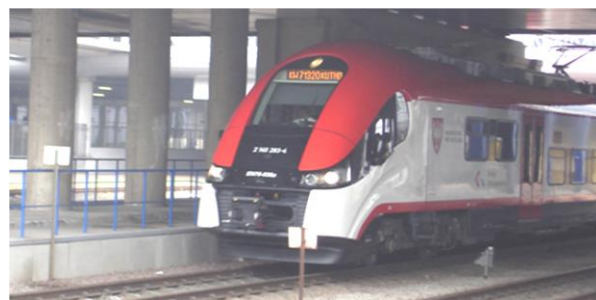
Fig. 3. View of the PESA ELF I vehicle [A.M. Rilo Cañas]

The test object were 4 electric multiple units PESA EN76 ELF I, as shown in Fig. 3. The vehicles were manufactured as four-unit units, but the number of units depends on the order of a given owner or railway carrier [14].

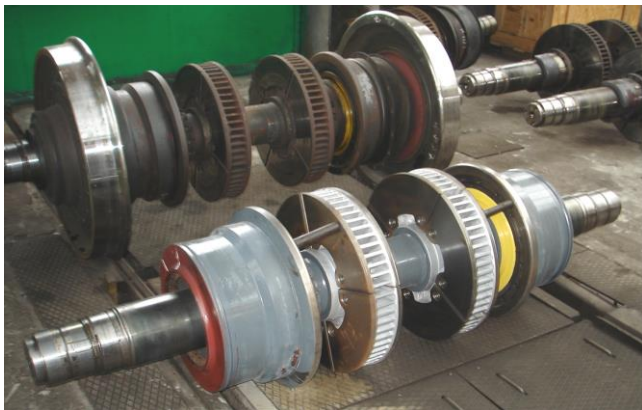
Fig. 15. View of the axle and the 1435/1520 mm SUW 2000 adjustable wheel set with split discs [W. Sawczuk]

The use of split discs in railway technology, due to their faster wear compared to the wheels, was already known much earlier. In 2000, a wheelset for a 1435- to 1520-mm gauge changeover system, designed by Dr. Ryszard Suwalski, was presented. In this wheelset, the designer deliberately used four-segment brake discs of his own design, mounted at the center of the wheelset axle between the wheel changeover and locking mechanisms, as shown in Fig. 15.
