Using vibroacoustic methods to describe the dynamic properties of composite elements to assess their technical condition

Wykorzystanie metod wibroakustycznych do opisu własności dynamicznych elementów kompozytowych w aspekcie oceny ich sprawności technicznej

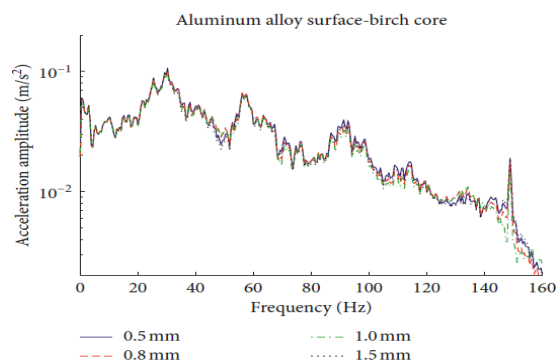
Fig. 3. A visual representation of the relationship between the vibrations acceleration value and the aluminum layer thickness in the floor material while moving at a speed of 350 km/h [11]

Rys. 3. Zależność wielkości przyspieszeń drgań od grubości warstwy aluminiowej w materiale podłogi podczas poruszania się z prędkością 350 km/h [11]

Przykładem zastosowania analizy drgań w diagnostyce materiałów kompozytowych zastosowanych w kolei dużych prędkości przedstawiono na rys. 3.

Podczas badań, których wynikiem była zależność przedstawiona na rys. 3 wykazano, że grubość warstwy powierzchniowej materiału kompozytowego, z którego wykonana jest podłoga pociągu kolei dużych prędkości wpływa bezpośrednio na widmo przyśpieszeń drgań – największe różnice widać przy wyższych częstotliwościach [11].

During the tests, which resulted in the relation presented in Fig. 3, it was shown that the thickness of the surface layer of the composite material which makes up the floor of the high-speed railway train directly affects the spectrum of vibration accelerations – the greatest differences can be observed at higher frequencies [11].

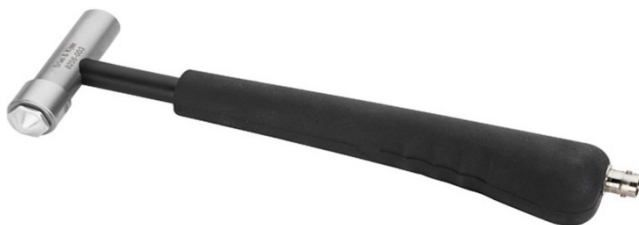
Fig. 8. Brüel & Kjær type 8206 modal hammer - manufacturer's diagram [3]

Rys. 8. Młotek modalny – Brüel & Kjær typ 8206 – schemat producenta [3]

For the impulse test, a type 8206 modal hammer from Brüel & Kjær with a sensitivity of 22.7 mV/N was used as an inductor to generate the initial signal.

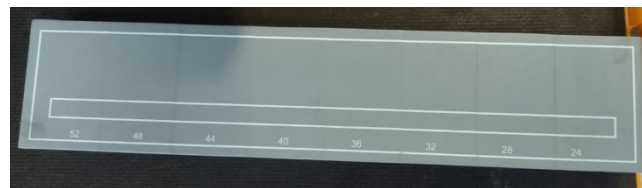
Fig. 6. Picture of the damaged sampler

Rys. 6. Rzeczywisty wygląd próbnika z uszkodzeniami

Standard samplers made using an element made of a composite material were tested in the research. The structurally intact sampler was compared with the sampler containing structure defects, the diagram of which was shown in Fig. 5, and a real picture in Fig. 6.

Both samplers, undamaged and with structural damage, were made of a material with an aluminum matrix and reinforced with a sealing compound. The cover was made out of graphite plates and the binding agent used was an epoxy resin.

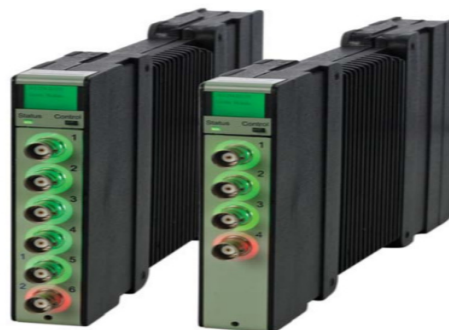
Fig. 7. Brüel & Kjær type 3050 data acquisition module - manufacturer's diagram [2]

Rys. 7. Moduł akwizycji danych Brüel & Kjær typu 3050 – schemat producenta [2]

A Brüel & Kjær 3050 type dynamic signal acquisition unit was used to record and process the tested signals. The device made it possible to measure the sound pressure using up to 6 input channels as well as being able to power 200V microphones. The acquisition module enabled the signal recording at a sampling rate of up to 131,072 samples per second.

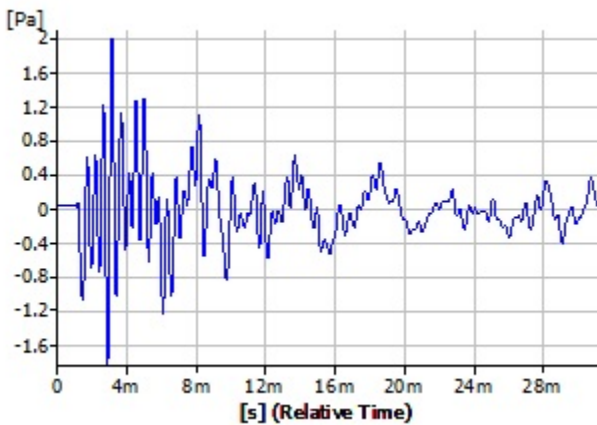
Fig. 10. The acoustic pressure signal in time domain after a force has been applied to the undamaged element

Rys. 10. Przebieg sygnału ciśnienia akustycznego w czasie po zadziałaniu wymuszenia na element nieuszkodzony

Na rysunku 10 przedstawiono przebieg ciśnienia akustycznego w czasie po zadziałaniu wymuszenia na element nieuszkodzony.

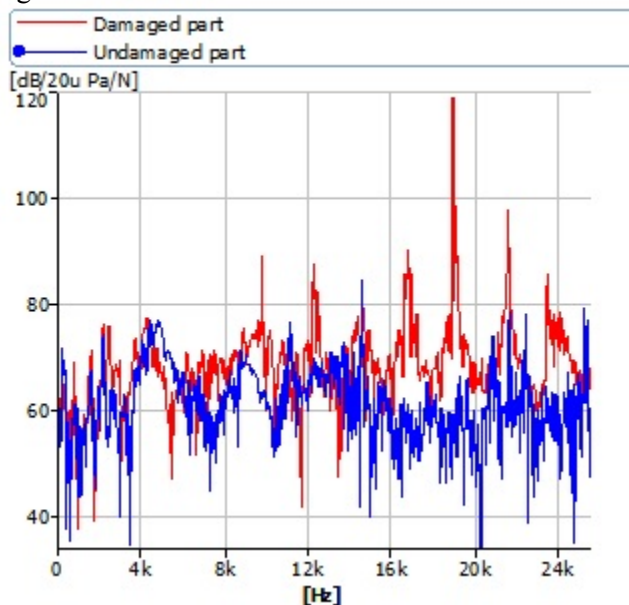
Fig. 12. FRF characteristics for the undamaged (in blue) and damaged (in red) elements

Rys. 12. Charakterystyka FRF dla elementu nieuszkodzonego (kolor niebieski) i uszkodzonego (kolor czerwony)

The difference in the tone of sound between the damaged and intact element during the testing was audible to the unaided ear. The sound generated by the composite element with the structural defect during the impact test was perceived as a signal with stronger treble than the sound for the composite without any damage. In order to compare the acoustic signals with each other, the frequency response functions were determined, with the input data in the form of a modal hammer impact force for the damaged and undamaged elements. The comparison of the FRF was shown in Fig. 12.

W trakcie badań słyszalna była uchem nieuzbrojonym różnica w tonie dźwięku pomiędzy elementem uszkodzonym i sprawnym. Dźwięk generowany przez kompozyt z defektem w trakcie testu uderowego odbierany był jako sygnał silniejszych tonach wysokich niż kompozyt bez uszkodzeń. W celu porównania sygnałów akustycznych między sobą wyznaczono funkcje odpowiedzi częstotliwościowej, z daną wejściową w postaci siły uderzenia młotka modalnego, dla elementu uszkodzonego i nieuszkodzonego. Porównanie FRF przedstawiono na rys. 12.

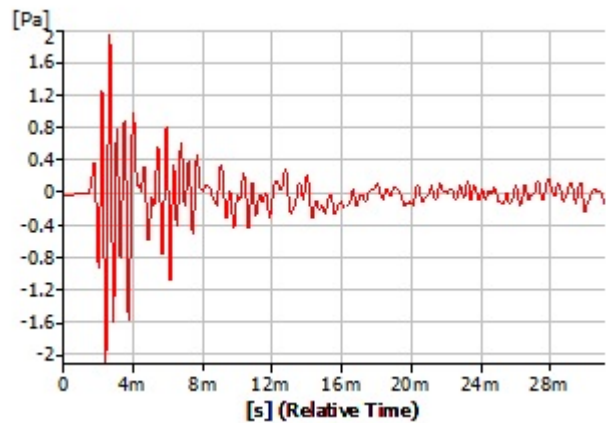
Fig. 11. The acoustic pressure signal in time domain after a force has been applied to the element with structural damage

Rys. 11. Przebieg sygnału ciśnienia akustycznego w czasie po zadziałaniu wymuszenia na element uszkodzony

Analogiczny przebieg sygnału przedstawiony jest na rys. 11 dla elementu uszkodzonego.

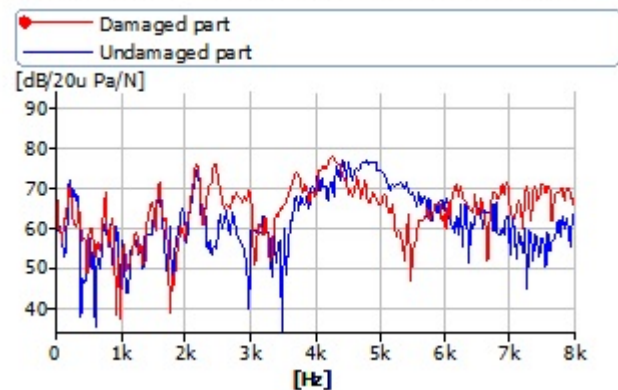
Fig. 13. FRF characteristics for the undamaged (in blue) and damaged (in red) elements in the 0-8kHz range

Rys. 13. Charakterystyka FRF dla elementu nieuszkodzonego (kolor niebieski) i uszkodzonego (kolor czerwony) w paśmie 0-8kHz

When analyzing Fig. 13, diagnostically significant differences can be observed in three local points of the signal:

- pojawienie się dodatkowego modu dla częstotliwości 2,4 kHz dla części uszkodzonej (rys. 14),
- przesunięcie fazowe (rys. 15)
- zmiana przebiegu charakterystyki (rys. 16).

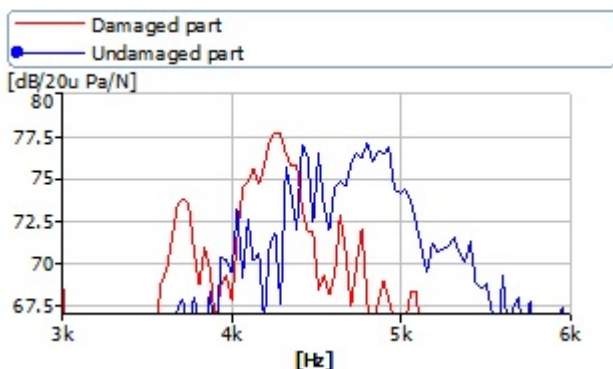
Fig. 15. FRF characteristics for the undamaged (in blue) and damaged (in red) elements – in the 3-6 kHz range

Rys. 15. Charakterystyka FRF dla elementu nieuszkodzonego (kolor niebieski) i uszkodzonego (kolor czerwony) – w paśmie 3-6 kHz

It can be observed (Figure 15) that structural damage causes a negative phase shift in the described frequency range – the frequency mode of 4928 Hz of an intact composite element has been shifted to 4256 Hz as a result of a structural defect.

Na rysunku 15 można zaobserwować, że uszkodzenie w strukturze powoduje w opisanym paśmie ujemne przesunięcie w fazie – mod częstotliwościowy 4928 Hz elementu sprawnego technicznie uległ przesunięciu do 4256 Hz w wyniku defektu strukturalnego.

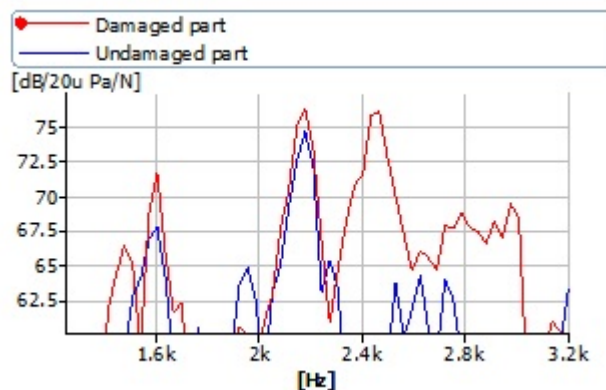
Fig. 14. FRF characteristics for the undamaged (in blue) and damaged (in red) elements – the additional mode for the frequency of about 2.4 kHz

Rys. 14. Charakterystyka FRF dla elementu nieuszkodzonego (kolor niebieski) i uszkodzonego (kolor czerwony) – dodatkowy mod dla częstotliwości 2,4 kHz

- appearance of an additional mode for the frequency of 2.4 kHz for the damaged part (Fig. 14),

Analysis of Figure 14 allows to conclude that structural damage of the composite element causes an additional mode to appear at the 2464 Hz frequency with the same sound pressure level as for the 2176 Hz mode.

Analizując rysunek 14 można stwierdzić, że uszkodzenie struktury elementu kompozytowego powoduje powstanie dodatkowego modu dla częstotliwości 2464 Hz o poziomie ciśnienia akustycznego takim samym jak poziom dla modu 2176 Hz.

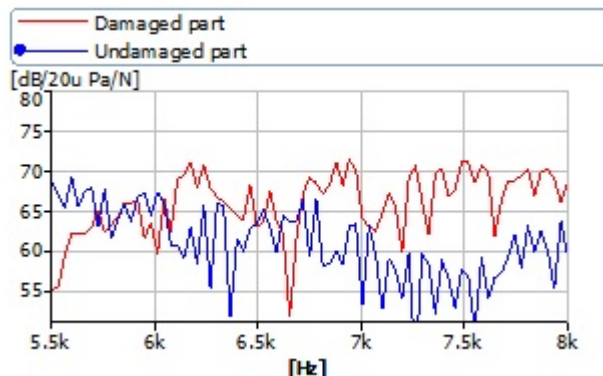
Fig. 16. FRF characteristics for the undamaged (in blue) and damaged (in red) elements – in the 5.5-8kHz range

Rys. 16. Charakterystyka FRF dla elementu nieuszkodzonego (kolor niebieski) i uszkodzonego (kolor czerwony) – w paśmie 5.5-8kHz

In the frequency range as shown in Fig. 16, the FRF characteristics for both elements can be seen to intersect and diverge. Up to the frequency of 6 kHz, the intact composite element could be seen to produce higher amplitudes than the damaged one. On the frequencies increased beyond 6 kHz, however, the sound pressure amplitude of the undamaged element decreased while the amplitude for the structurally damaged element significantly increased. For a frequency of 7264 Hz, the difference between the sound levels of the two elements was 15 dB. Such a difference is audible even to the unaided human. RMS values of the sound pressure level (Root Mean Square) for the frequency range immediately before the characteristic intersected and after that point were compared and are presented in Table 2.

W paśmie przedstawionym na rys. 16 można zaobserwować odwrócenie przebiegu charakterystyk FRF dla obydwu elementów. Do częstotliwości 6 kHz większymi amplitudami charakteryzuje się przez element sprawny technicznie. W wyższych częstotliwościach zmniejsza się amplituda ciśnienia akustycznego elementu nieuszkodzonego i znacząco wzrasta ona dla elementu z defektem. Lokalnie dla częstotliwości 7264 Hz różnica między poziomami dźwięku wynosi 15 dB. Różnica na takim poziomie jest słyszalna przez człowieka uchem nieuzbrojonym. Porównano wartości skuteczne poziomu ciśnienia

The effective value took into account the large instantaneous amplitude values and is the most frequently used point measure due to its proportionality to the process power [21]. By analysing the data presented in tab. 2, it can be noted that the RMS of the damaged element in both bands does not change substantially. In comparison for the technically intact element, the effective pressure level value drops by 10 dB at the moment when the characteristics intersect each other and switch places.
