## The characteristics of the selected types of wheel wear and their effect on the rail vehicle – track interaction

Marcin Słowiński<sup>a,\*</sup>

<sup>a</sup> Poznan University of Technology, Institute of Transport, Poznan, Poland

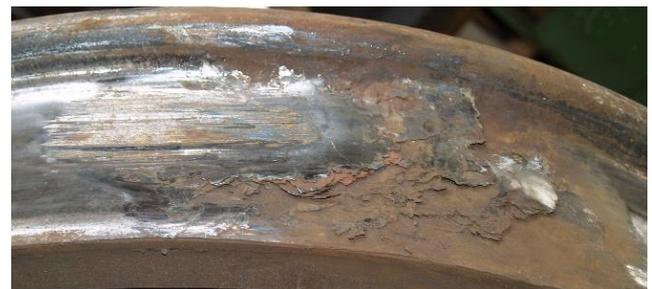
According to [15], a wheel flat can be defined as a local abrasion occurring on the wheel rolling surface, causing the loss of its original contour (Fig. 3). Wheel flat occurs as a result of sliding between the wheel and the rail, which is most often generated by wheel locking during braking due to poor technical conditions of the brake or improperly selected braking force. Other factors that contribute to wheel-rail slip are third-party bodies between the wheel and the rail (e.g. leaves, snow) or contamination of the rail surface. Fig. 4 shows a wheel flat on the wheel running surface.

Fig. 3. Wheel flat [16]

The formation of the wheel flat is related to abrasive wear and a martensitic transformation of the wheel rolling surface material. In this case, the mechanism of the wheel flat formation can be described in the following points [6]:

1. The occurrence of full slip between the wheel and the rail which is caused by an inappropriate braking process.
2. Local temperature rise at the wheel-rail interface because of the frictional energy dissipation.
3. Rapid cooling of the wheel running surface due to rotation of the wheel and conduction of heat into the wheel.
4. Generation of residual stresses and the formation of brittle and hard martensite on the wheel running surface.
5. Development of a flat spot as a consequence of cyclic contact stresses leading to abrasion of the martensitic layer.

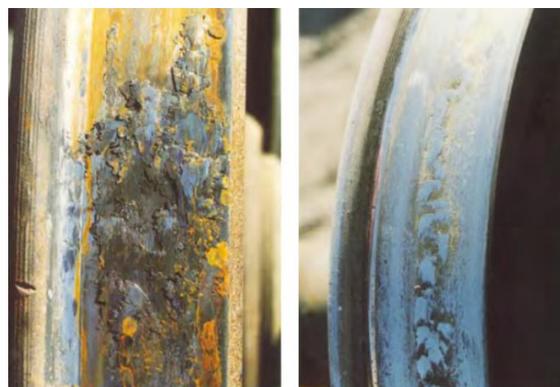
The scaled wheels phenomenon can be defined as sticking of the fragments of material to the wheel rolling surface. The first mechanism of its formation mentioned in the literature is related to sliding between the wheel and the rail, due to the complete wheel blocking during sudden braking [4]. In such a case, by the increase in the wheel temperature, the material becomes more plastic and is detached from one region of the rolling surface. After that, it sticks to another fragment of this surface. The result is an area with adhered material (Fig. 4).

Fig. 4. Scaled wheels [17]

Usually, during the scaled wheels formation, the plasticised wheel material is mixed with contaminants from the track or the brake system. The mechanism involves both a wheel flat and a scaled wheel genera-

tion – respectively a wheel flat is formed on the wheel, which releases material to the rail, and a scaled wheel is formed on the wheel, to which the material adheres.

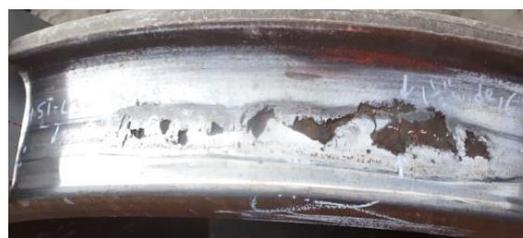
Wheel wear by shelling is manifested by the loss of a piece of material of the wheel tread [3]. Two basic types of this form of wear can be distinguished, which differ in the formation mechanism – shelling caused by fatigue of the rolling surface material and shelling generated by a slip between the wheel and the rail [14]. This type of wear is illustrated in Fig. 5.

Fig. 5. Shelling wear [18]

Shelling, caused by material fatigue, occurs as an outcome of plastic deformation originated from the cyclic contact stresses at the wheel-rail contact. When the yield point of the material is exceeded, fatigue cracks appear. Because of the continuous contact stresses, the cracks grow and merge with each other, resulting in either a cumulative crack or shelling of the wheel rolling surface material [5, 14].

Shelling originated from wheel sliding, unlike spalling wear, is generated by heating the entire surface layer of the wheel rolling surface above 300°C for an extended period of time. Due to the prolonged thermal effect, the surface layer of the tread is weakened and more susceptible to thermal cracks. The presence of contaminants such as sand or water between the wheel and the rail can promote the propagation of cracks deep into the cross-section of the surface layer [7].

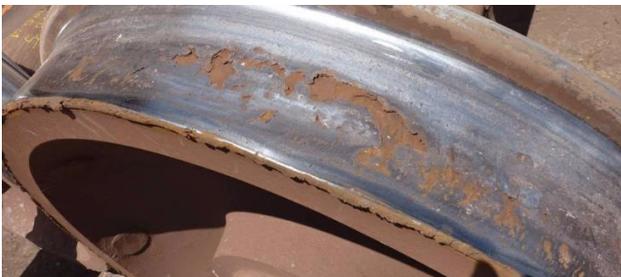
The essence of spalling wear is the loss of material particles from the component. Spalling wear on the wheel rolling surface is shown in Fig. 6. The specific feature of spalling wear and the main difference from shelling wear is the martensitic transformation, which occurs on the wheel rolling surface [13]. In the case of rail vehicle wheels, the mechanism of spalling wear formation can be presented in the following two stages:

Fig. 6. Spalling wear [19]

1. A local temperature rise in the surface layer of the wheel rolling surface due to the dissipation of frictional energy and, as a consequence, the formation of martensite.
2. Spalling of shallow martensite scales as an outcome of cyclic contact of the rolling wheel with the rail.
